28 Die in Pioneer Hotel, Tucson, Arizona

LAURENCE D. WATROUS

Supervisor, NFPA Fire Record Department

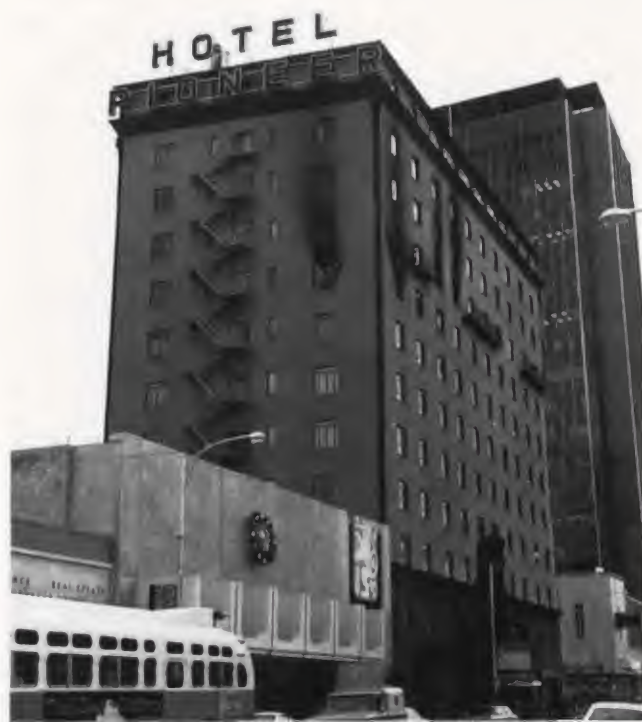
The main section, looking from the north. North Stone Avenue is in the foreground.

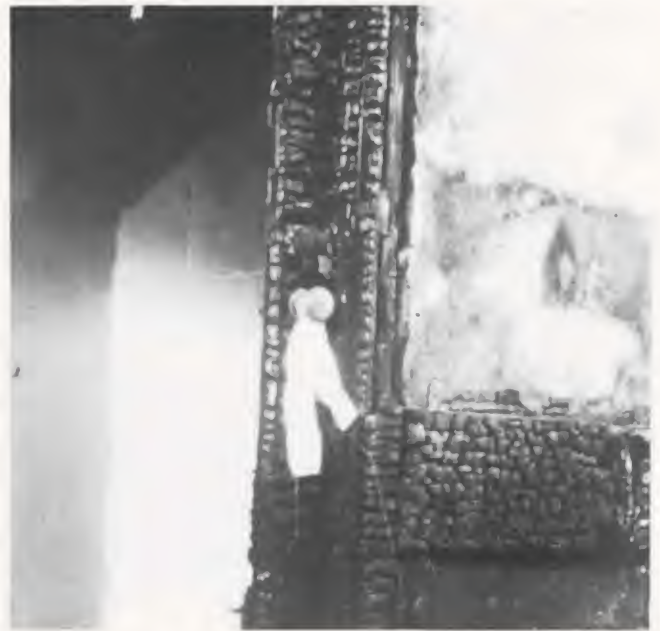
White rag still attached to doorway to indicate that the room had been searched. Such a procedure is an excellent idea during large search and rescue operations.

occupants on the eighth floor and five on the ninth floor. Three people on the eighth floor and one on the ninth floor died as the result of falls. To prevent confusion over which rooms had been searched, white rags were attached to the doorway of each room after it had been checked. Small hot spots were cooled down during and after the search. All men and apparatus had been returned to service by 8:00 am except one company, which remained as a fire watch until 3:00 pm.

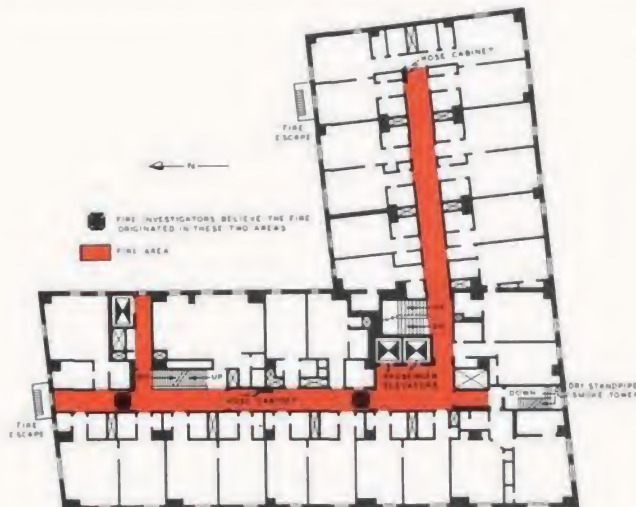
Figure 2. Floor plan of the fourth floor, which is typical of the third through sixth stories. The shading indicates the area on the fourth floor destroyed by fire.

INVESTIGATIONS BY THE FIRE DEPARTMENT FIRE PREVENTION DIVISION found that two fires had started at two locations on the fourth floor of the main section, separated by about 60 feet. Officials believe the fires originated at floor level against the wall, where the floor carpet met the wall carpet. They feel the fires were set sometime before midnight and that they spread rapidly, joining and then spreading up the two open stairways. Lack of sufficient air allowed incomplete combustion to generate large quantities of fire gases and thick smoke. During the early stages, before the fire had taken control of the upper corridors, very few people were able to make their way to safety by way of the stairs and elevators. The fire quickly cut off the means of egress — the corridors. Very few people became aware of the fire in time, as there was no alarm system. Only those who smelled smoke or heard cries of fire in time were able to escape unaided. Several occupants made bed-sheet ropes to escape from their rooms. Several others shinned down electrical conduit attached to the rear of the building and adjacent to their windows as smoke entered around the doors and filled their rooms. Others threw mattresses to roofs below and jumped, some receiving injuries. Most of the occupants were rescued over Fire Department ladders.

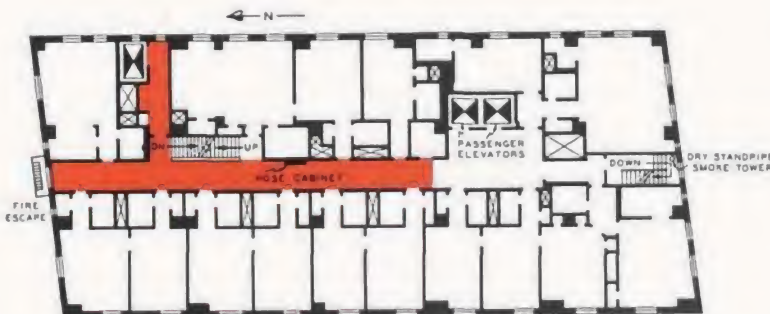
Figure 3. Floor plan of the tenth floor, which is typical of the seventh through eleventh stories. The shading indicates the area on the tenth floor destroyed by fire.

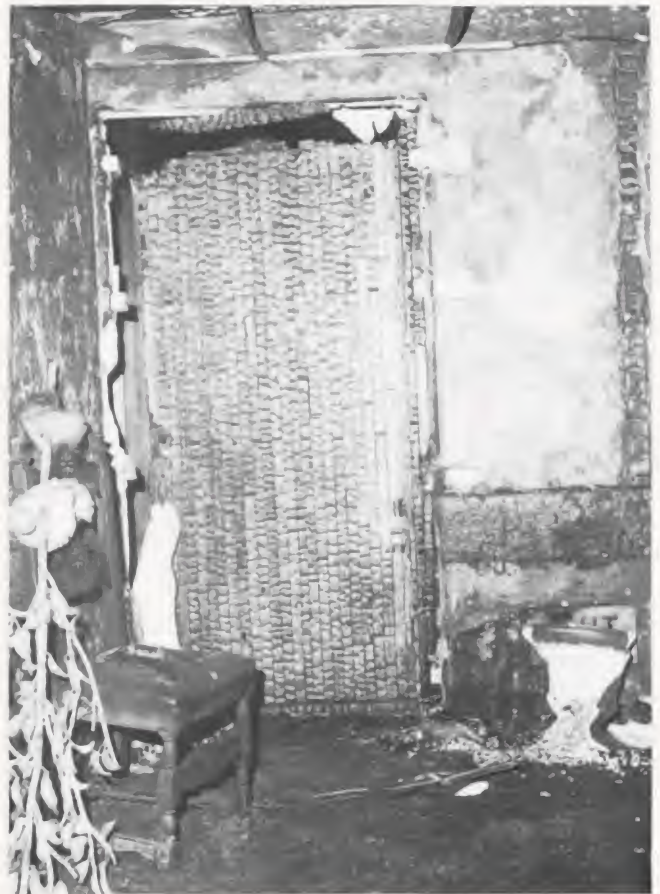
The side of a solid-core door that was exposed to the fire. Stairs are located just to the right behind the photographer.

Although a solid-core door on the eleventh floor at the top of the stairs withstood the force of the fire, it had not been installed properly. The door was too small for the opening in the tile wall and wood had been installed around it to make it fit. This wood around the door burned off and allowed the fire into a void space in the wall above the door. Heat and smoke filled the rooms behind this door, killing the occupants. The two permanent residents who occupied the area had been living in the building since it opened. It is ironic that they died, because there was a fire escape within several feet of where their bodies were found. Several years ago the window to the fire escape had been covered over with a canvas sheet painted the same color as the wall. A light drape had been hung to cover this part of the wall.

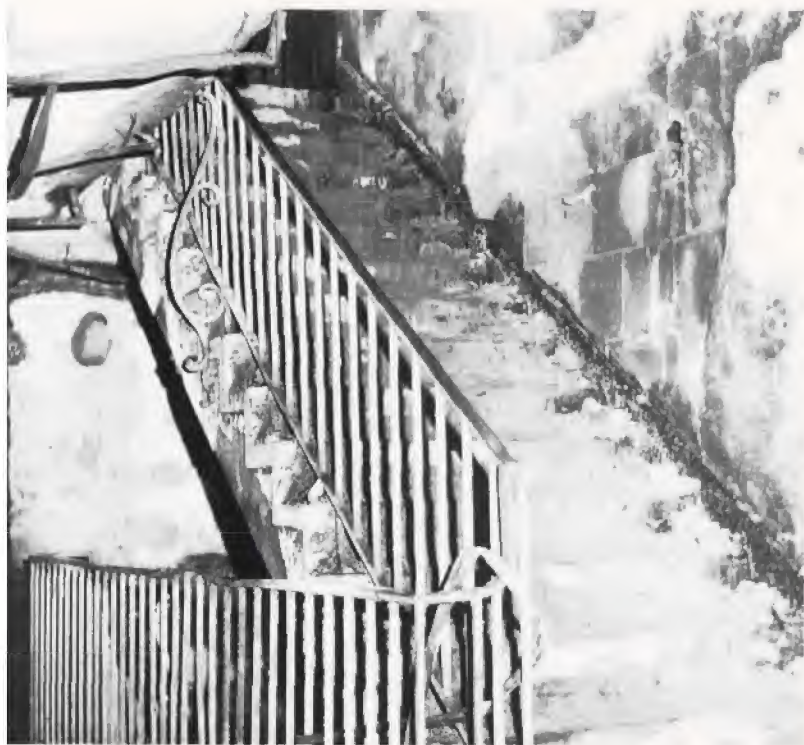
Top: The stairway from the fifth to the sixth floor. Note how the heat bent the railing and spalled the plaster covering the tile wall.

IT IS VERY DIFFICULT to protect a building from arson fires. However, once the fire is started there should be ways of slowing its progress. Closed fire doors on enclosed stairways would have greatly limited the vertical spread of heat and fire gases. While the fire originated on the fourth floor and spread through all the corridors to the roof, only rooms on the sixth, eighth, and ninth floors were severely damaged by fire. The occupants who died were located on the sixth through the elev-

enth floor. Enclosed stairways and closed fire doors would probably have held the fire to one floor.

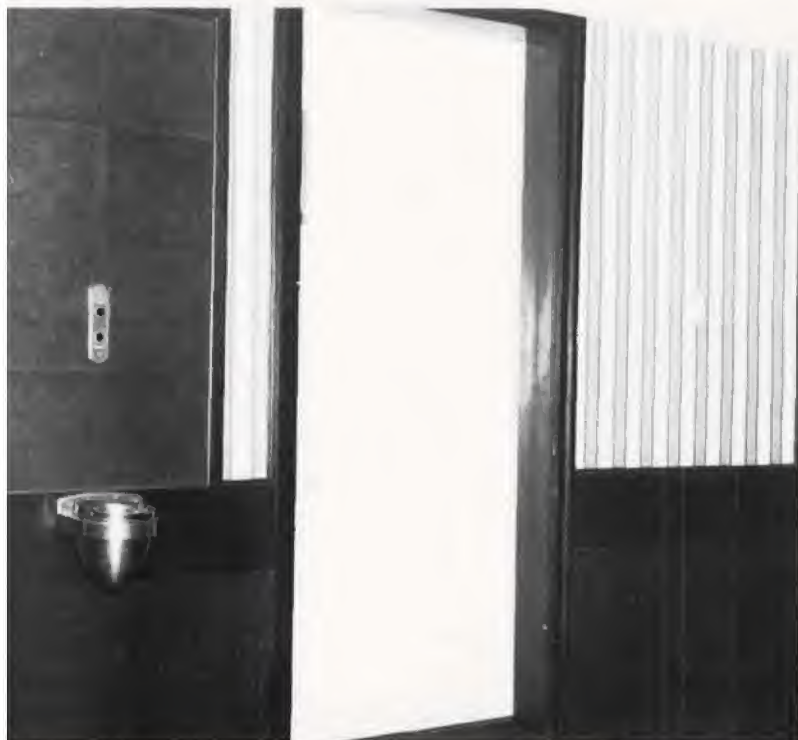
Above: The third-floor elevator lobby. Note the carpeting, the eight-inch strip of laminated plywood, and the plastic wall covering. All the elevator lobbies were alike.

The walls, ceiling, and floors of the corridors were of masonry or plaster construction and, therefore, did not contribute to the fire load. The carpet and the wall covering did, however, and to a degree sufficient to cause the fatalities and the severe damage.

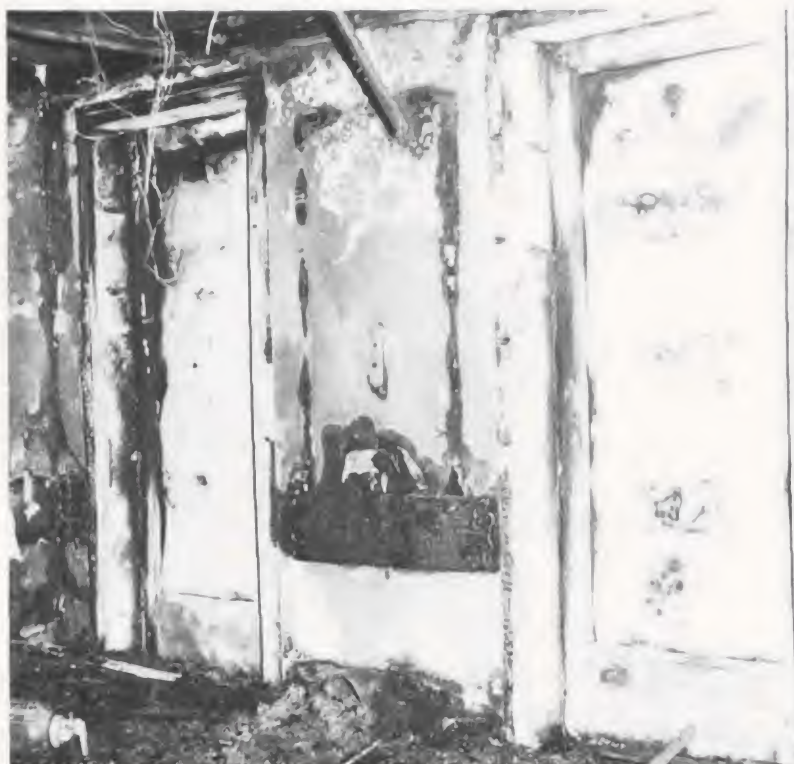
Top: The fifth-floor elevator lobby after the fire. The interiors of the doors were discolored but no fire passed into the shaft.

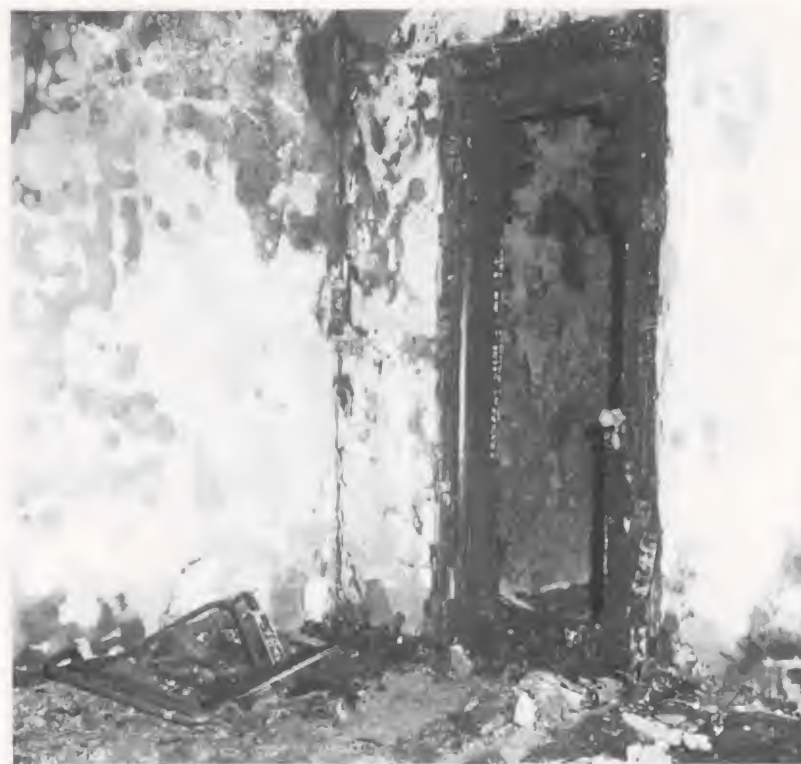
The light panel doors held up fairly well and did not allow a significant amount of fire into the rooms, even though there was severe burning in the corridors. The rooms in which the doors had been opened and left open were completely burned out by superheated fire gases that burned viciously when mixed with the fresh air in the rooms.

Above: This room is on the eighth floor. The door to the corridor was left open during the fire.
